**UPRN:**  
**Fox Primary School**  
**Kensington Place**  
**London**  
**W8 7PP**

**Project Number:** C-39091\_Rev1  
**Survey Date:** 16/02/2015  
**Client Contact:** Paul Tsangarakis  
The Town Hall  
Hornton Street  
London  
W8 7NX  
**Address:**  
**Tel:** 02078136685

## 1.0 EXECUTIVE SUMMARY

This report is a Refurbishment/Demolition Survey of those areas of the premises instructed by the Client and identified on the plan enclosed in the report.

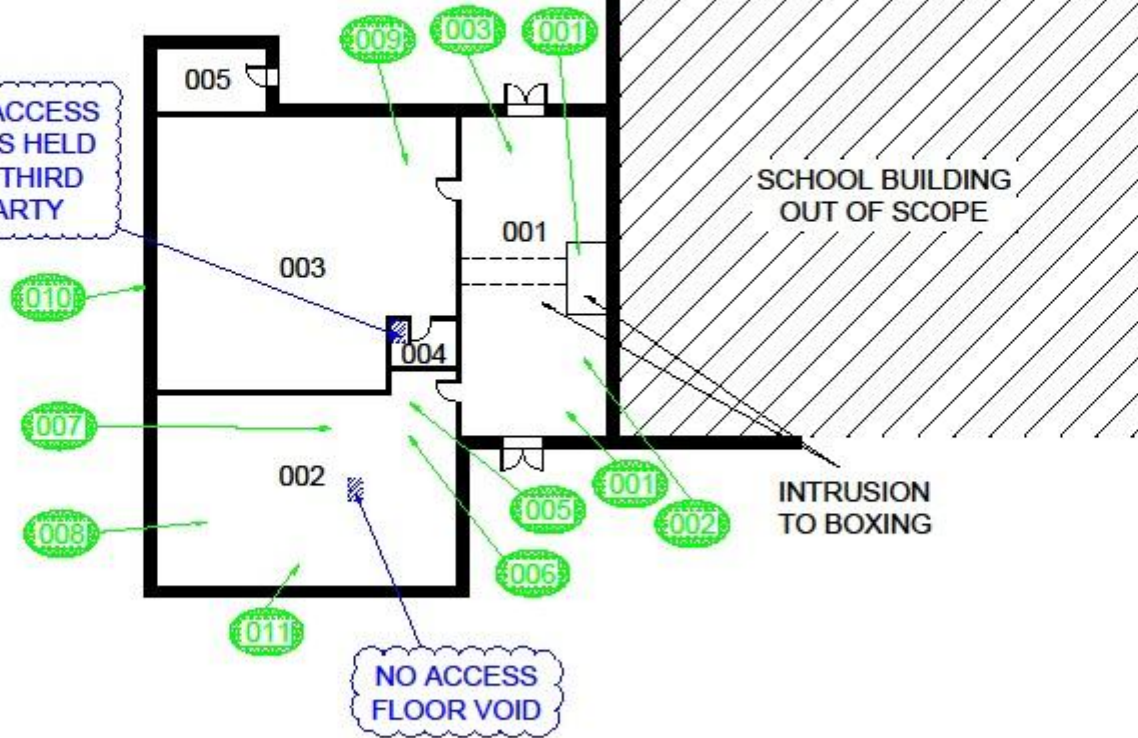
GROUND FLOOR

NO ACCESS  
KEYS HELD  
BY THIRD  
PARTY

INTRUSION  
TO BOXING

NO ACCESS  
FLOOR VOID
