Royal Borough of Kensington and Chelsea

Fox Primary School

Golder Associates (UK) Ltd Monitoring Results

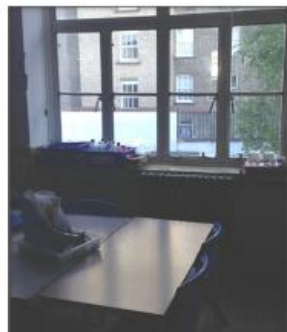
10. Classroom I middle window sill (front left)

10	<0.01	Interior sample - first floor - northern side of school building - window sill
11	0.05	Interior sample - first floor - northern side of school building - window sill
